# HUFF RUN WATERSHED REPORT

# 2017–2018 NPS Report - Huff Run Watershed

## Timeline of the Huff Run Watershed Project Milestones & AMD Projects

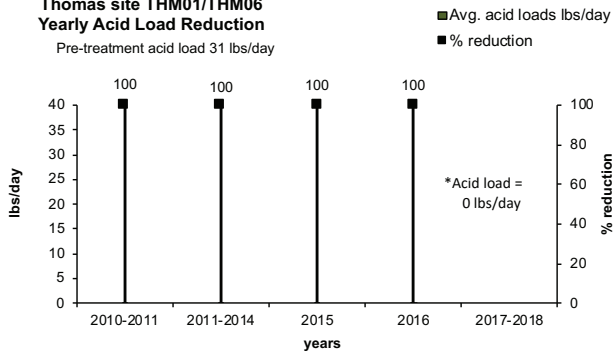
#### Thomas site THM01/THM06 Yearly Acid Load Reduction

Pre-treatment acid load 31 lbs/day

\*One sampling event over report period, on 11/14/2018.

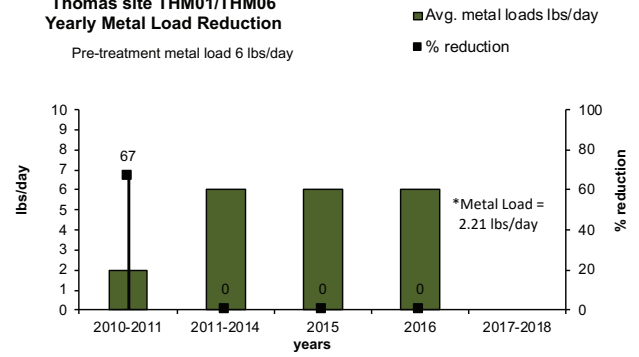
#### Thomas site THM01/THM06 Yearly Metal Load Reduction

Pre-treatment metal load 6 lbs/day

\*One sampling event over report period, on 11/14/2018.

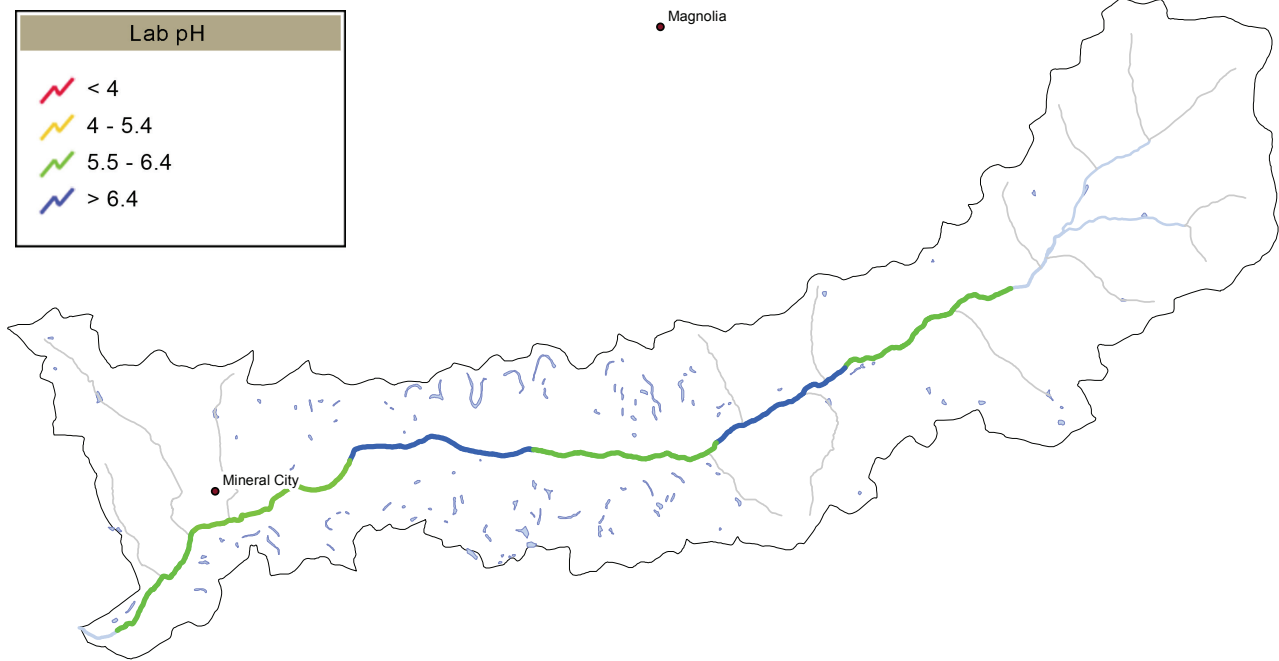
### Huff Run baseline pH

Huff Run pH values have improved from baseline conditions (1985-1998) to 2016. All of the 10 miles monitored in Huff Run in the 2017-2018 reporting period met the minimum pH target of 6.5.

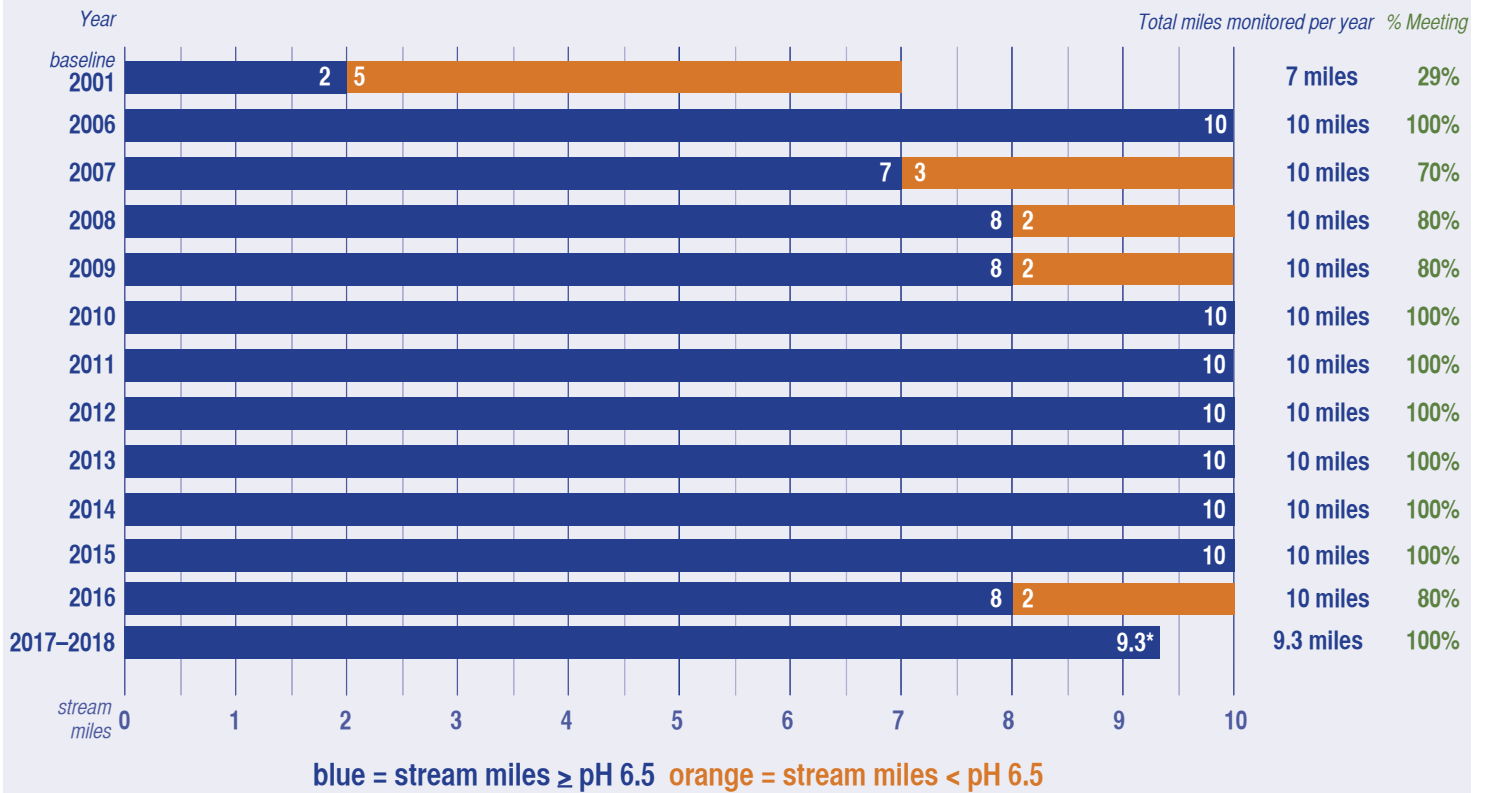
### Huff Run pH

The mainstem of Huff Run is approximately 10 miles in length. In 2009, 8 miles met the pH target of 6.5, while the two downstream reaches (HRR08 and HRR07) fell slightly below the target with an average of 6.4. From 2010 to 2015, all 10 miles met the target. 2016 was similar to the 2008- 2009 stream conditions, where the mouth of Huff Run fell just below meeting the pH target, leaving approximately 8 miles meeting and 2 miles slightly less than 6.5. In the 2017-2018 reporting period, Huff Run once again met the pH targets at all sites monitored, however, site HRR04, a 0.7 mile segment, was not monitored so is not included in total miles.

\*Site HRR004 (0.7 mile reach) not monitored during this sample period.

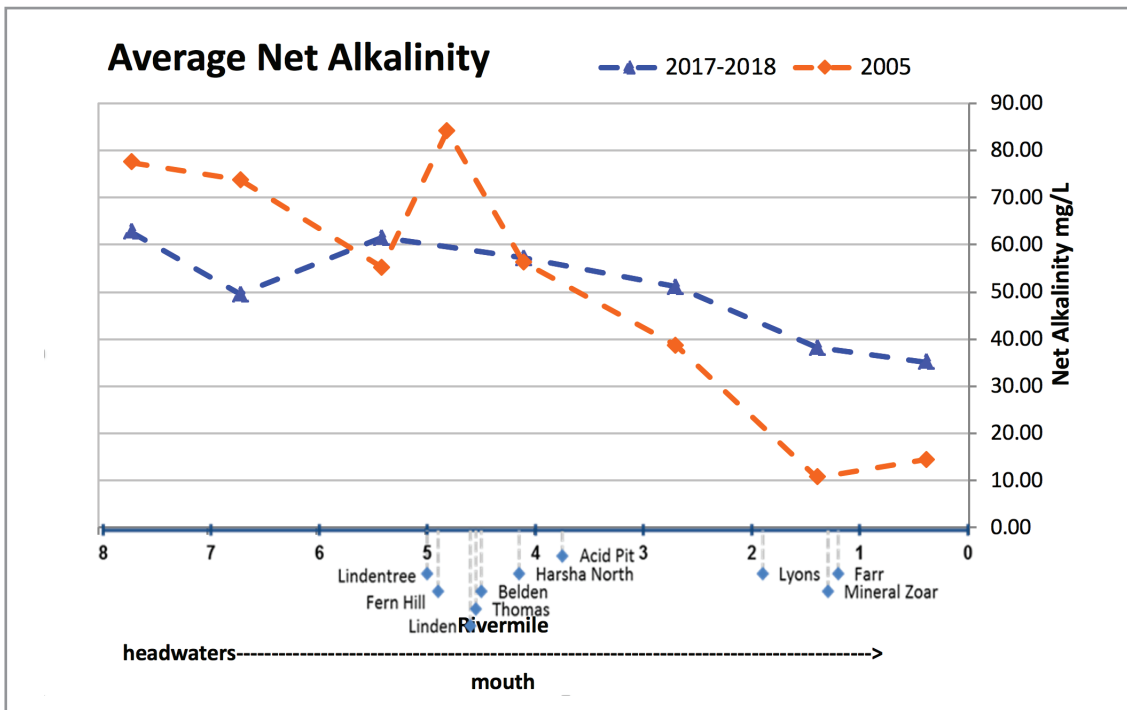
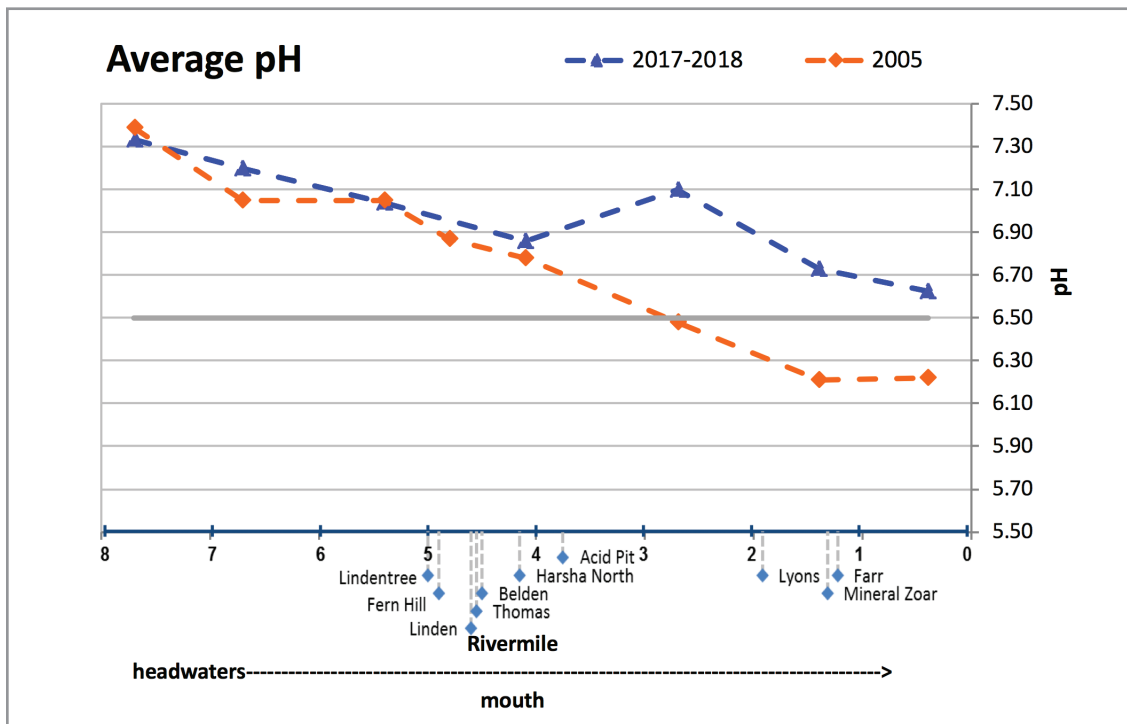
## Chemical water quality analysis per stream reach

Chemical water quality changes along the mainstem of Huff Run are shown in the stream reach graphs below. Chemical long-term monitoring data is utilized to generate line graphs along the stream gradient from headwaters to the mouth. Along the x-axis named tributaries are shown to illustrate sources of water entering the mainstem. A list of long-term monitoring sites utilized to generate the graphs with their river miles are shown below.

Huff Run								
Site ID	HRR01	HRR02	HRR03	HRR04	HRR05	HRR06	HRR07	HRR08
Rivermile	7.7	6.7	5.4	4.8	4.1	2.7	1.4	0.4

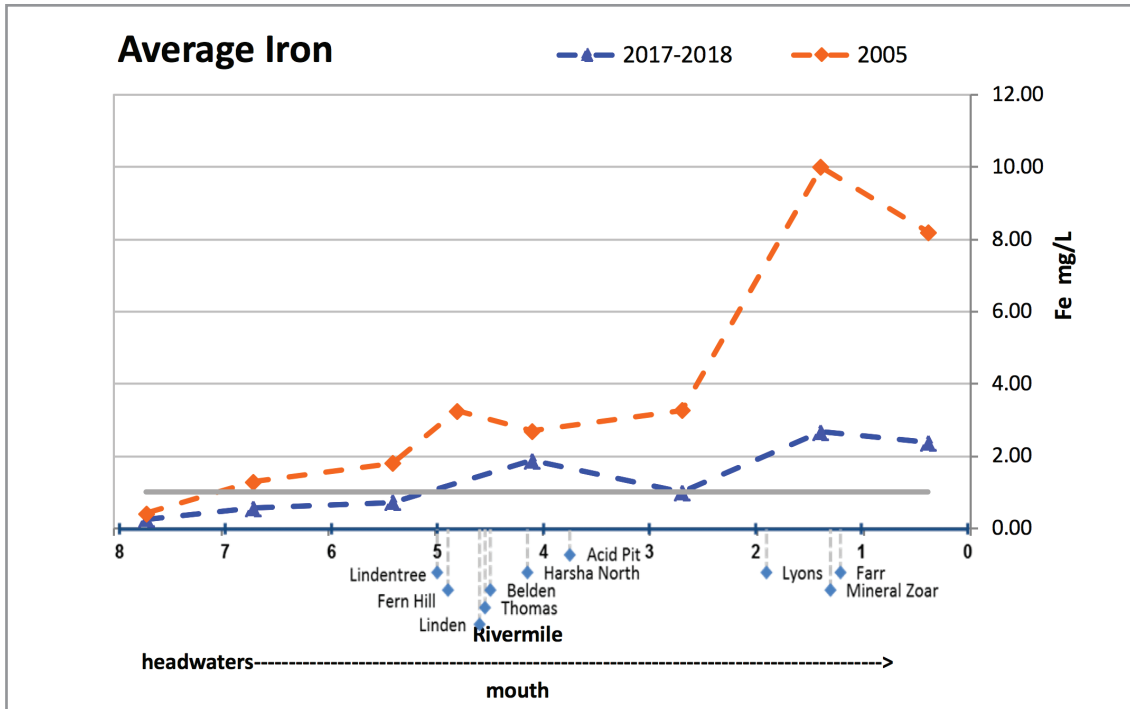
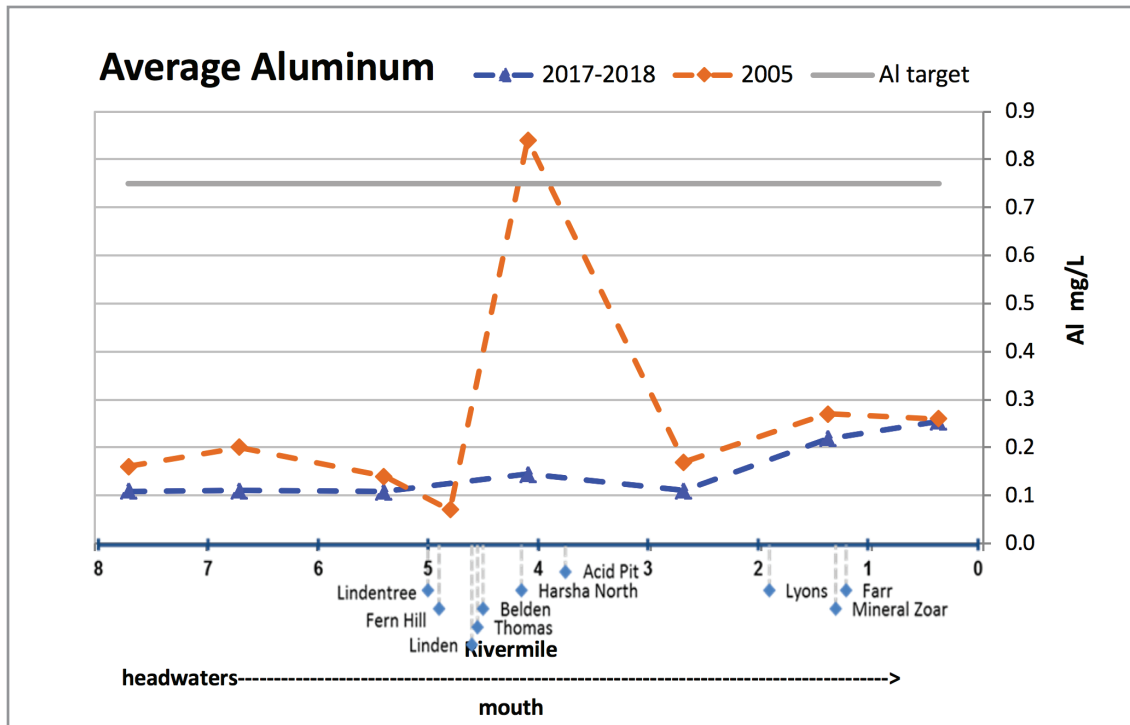
Huff Run								
Site ID	HRR01	HRR02	HRR03	HRR04	HRR05	HRR06	HRR07	HRR08
Rivermile	7.7	6.7	5.4	4.8	4.1	2.7	1.4	0.4

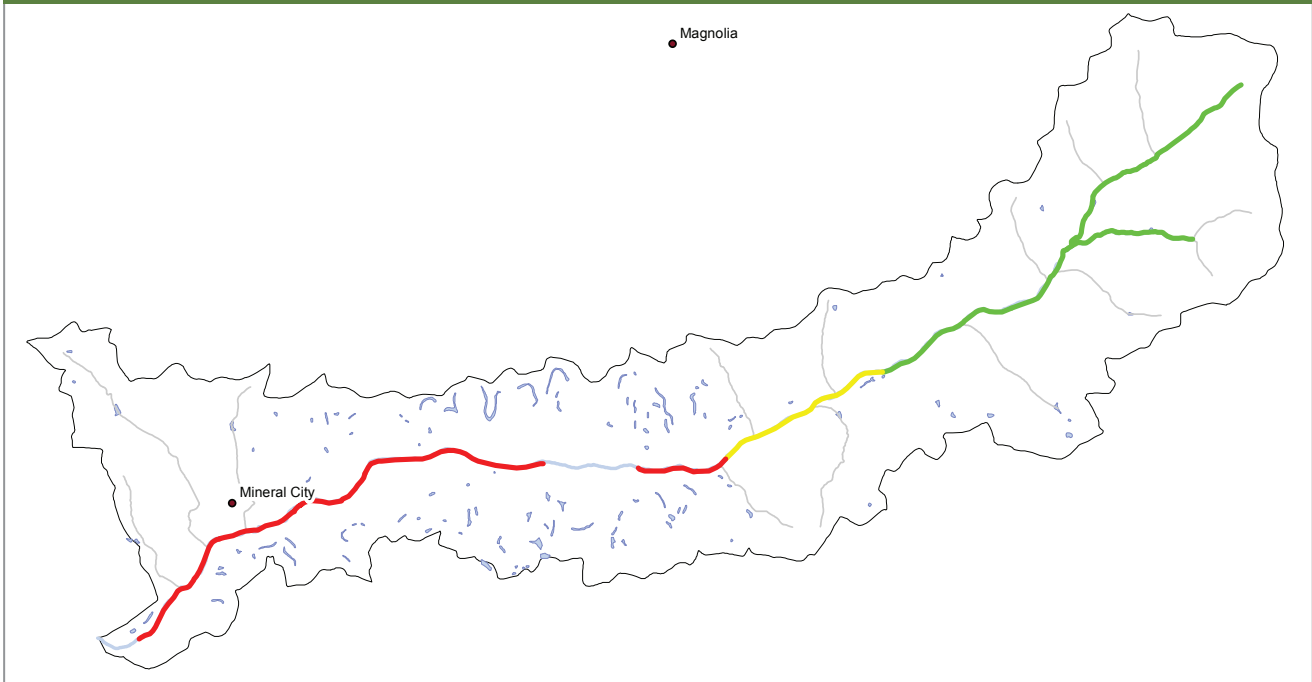
### Huff Run baseline MAIS

Biological quality in Huff Run decreases from headwaters to the mouth.

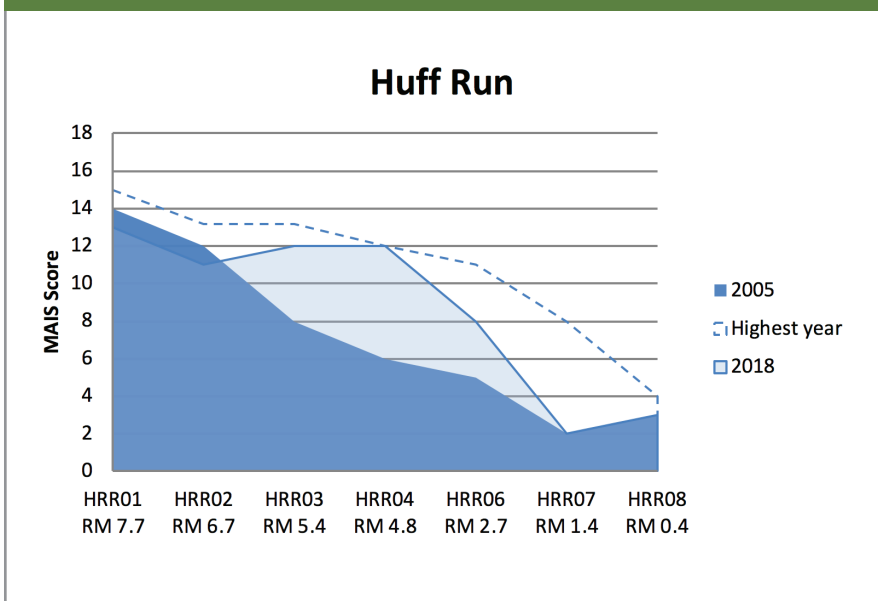
### Area of Degradation 2005-2018

Biological recovery of the macroinvertebrate community in Huff run since 2005 has been relatively slow but steady in the upstream portions of the watershed. The uppermost two sites have not changed much, with the most upstream site at RM 7.7 already meeting the MAIS target and the site immediately downstream (RM 6.7) almost meeting it. 2014 was the first year that other sites (RM 5.4) showed sustained and statistically significant improvement in MAIS scores. Three upstream sites (RM 7.7, 4.8 and 2.7) achieved their highest scores that year. In 2015, RM 5.4 met the biological restoration target of a MAIS score >12. Between 2016 and 2018, all four of the upstream monitoring sites (RM 7.7, 6.7, 5.4 and 4.8) had met the restoration target of an MAIS score > 12 at least once. The biology at RM 2.7 has improved significantly since 2012 but has not met the restoration target of 12 yet. The two downstream sites (RM 1.4 and 0.4) show no improvement in MAIS scores.
